LAWRENCE
LIVERMORE
NATIONAL
LABORATORY

LLNL-TR-648143

A Visual Description of the Concrete Exterior of the Cactus Crater Containment Structure

October 2013

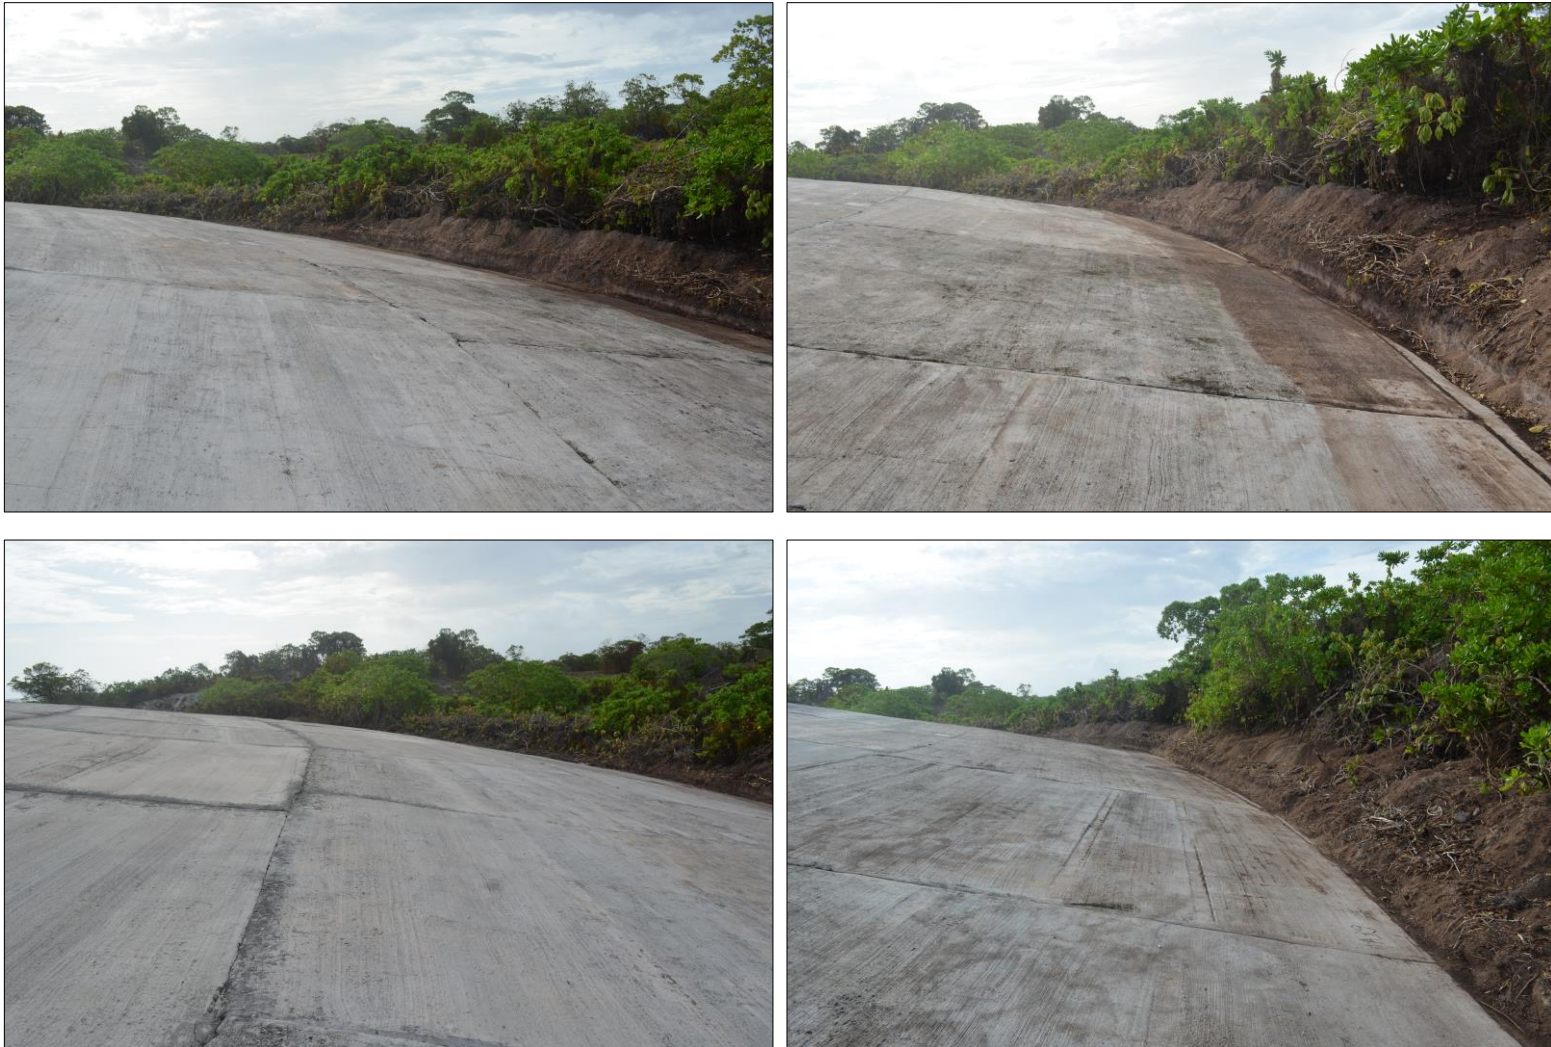
Fig 12. Vegetation growth over the face of *Runit Dome* (Initial conditions, Visual Survey, May 2013).

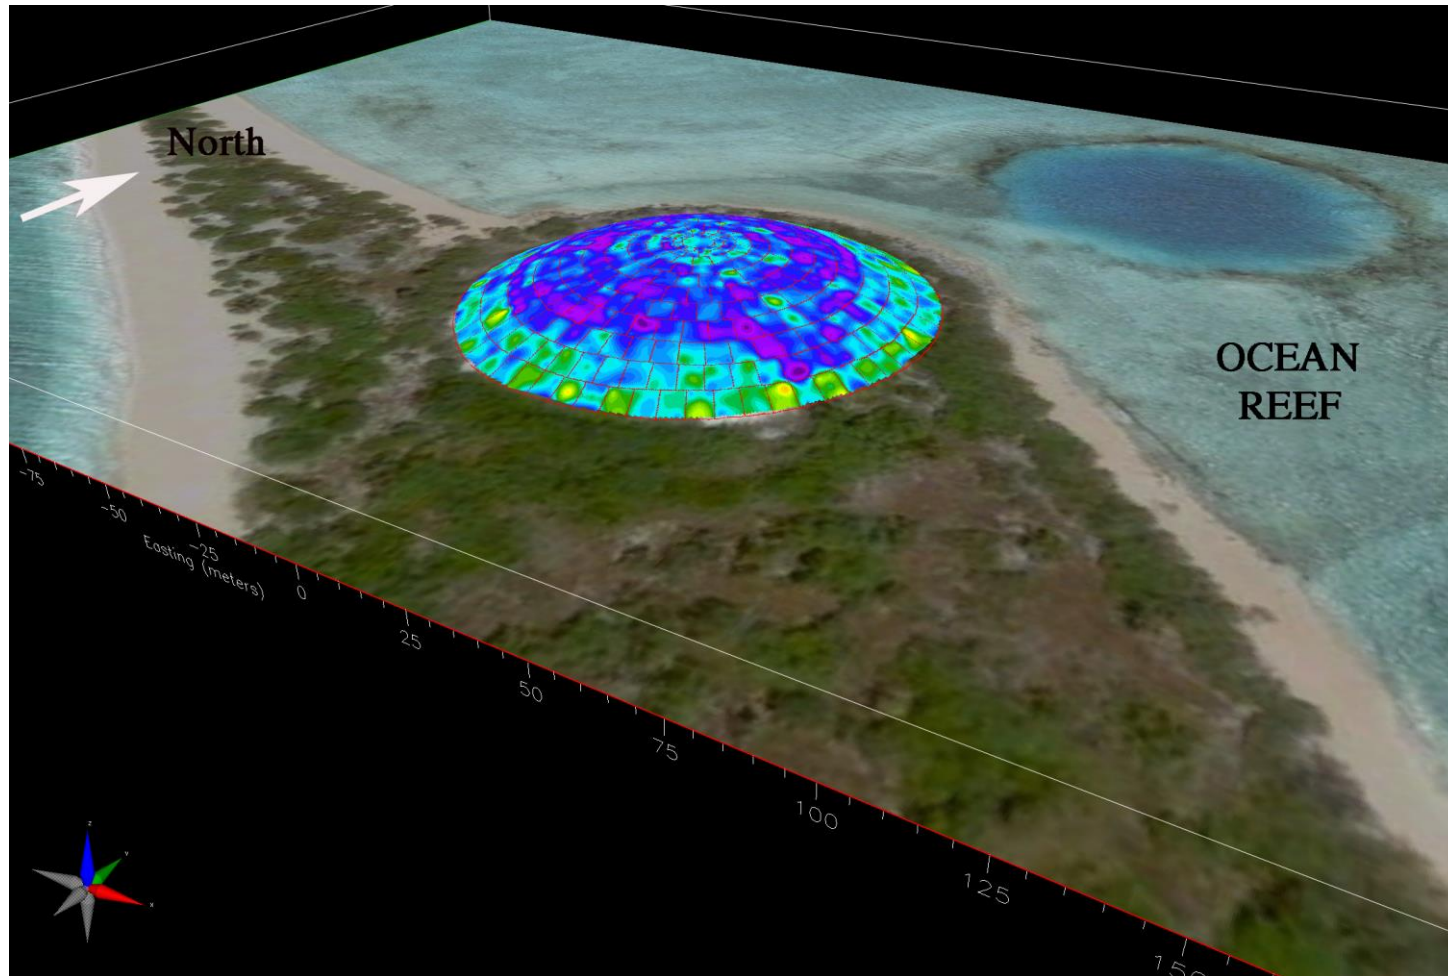
The design thickness of the concrete cap was 45 centimeters (DNA, 1981). The IE and SASW tests indicate that the majority of the concrete is in a structurally “sound” condition but the thickness of the cap is highly variable. The average thickness of the concrete cap was measured at 43 centimeters

Fig. 42. A Google map image showing a contour-plot overlay of the relative thickness of the concrete cap covering *Runit Dome* (*Impact Echo (IE)* measurements with the thinnest areas around the middle of the dome represented in a darker bluish, purple shade) [compiled from data collected by Olsen Engineering, Inc., Visual Survey, May 2013].

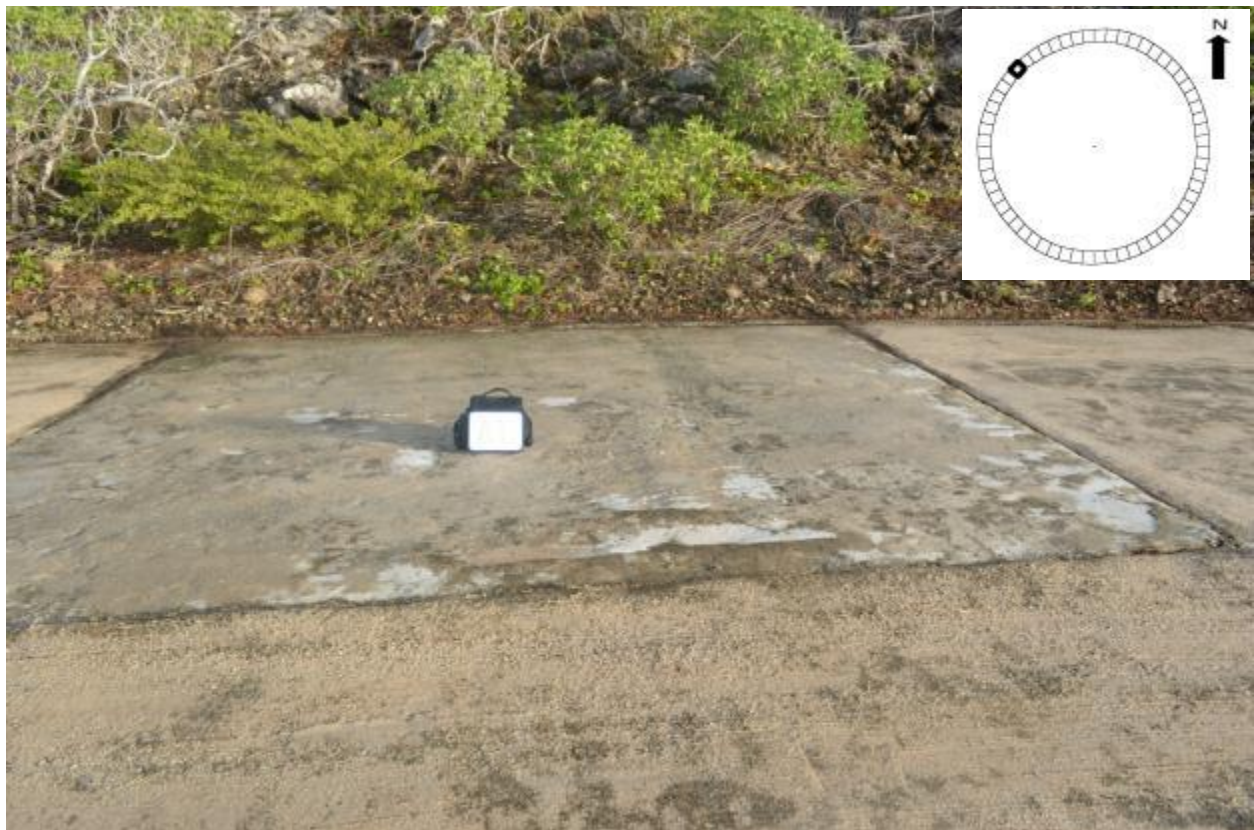
The panel contains no identification markings but occupies position A1. No significant or obvious interior cracks extending across the top of the panel. The surface of the concrete appears to have been refinished. There are some minor cracks and spalling of concrete in the upper right-hand corner of the panel, and along the seam adjacent to the corner intersection between panel B1 and B2.

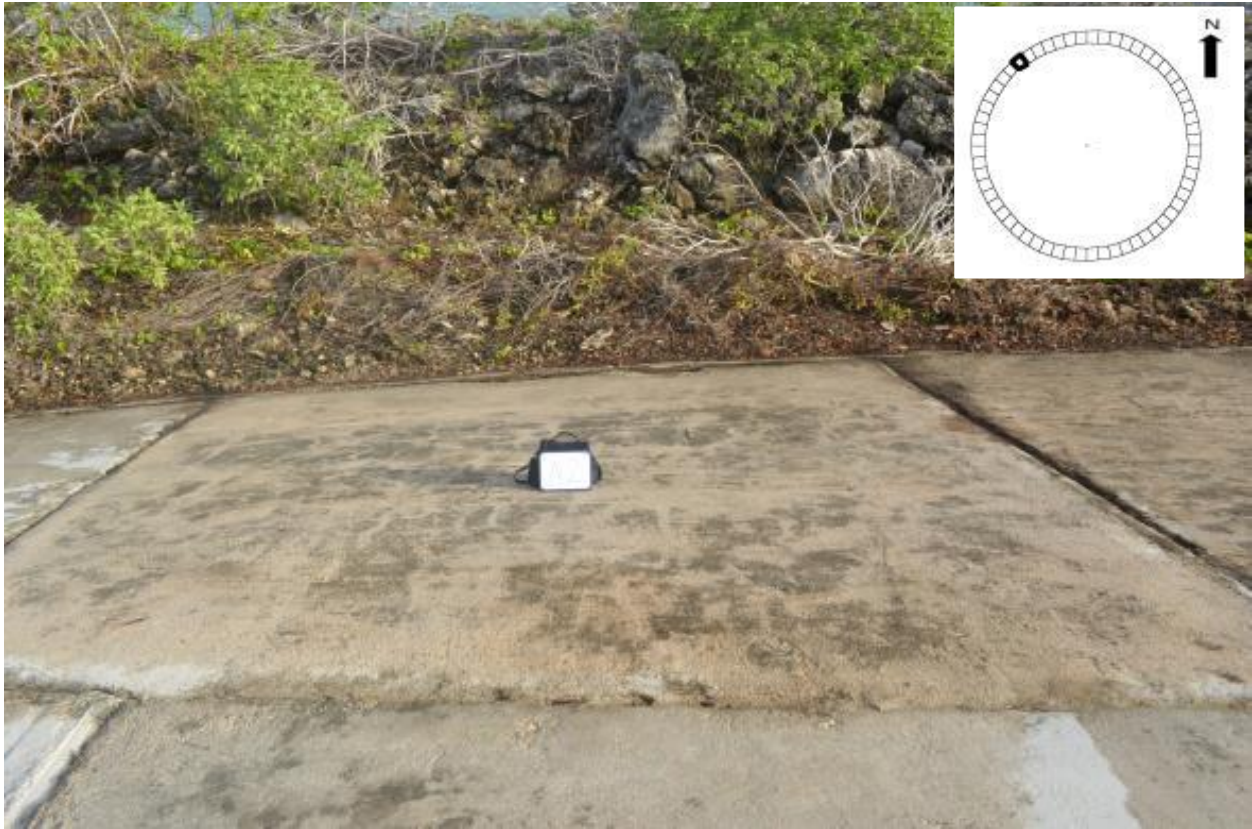
CAP SECTION LOCATION: Panel A2

Some rooting vegetation removed from along the panel seams. There is significant spall of concrete (about 2-3 meters wide, and up to 5-10 centimeters deep) running along the bottom seam adjacent to the keywall.

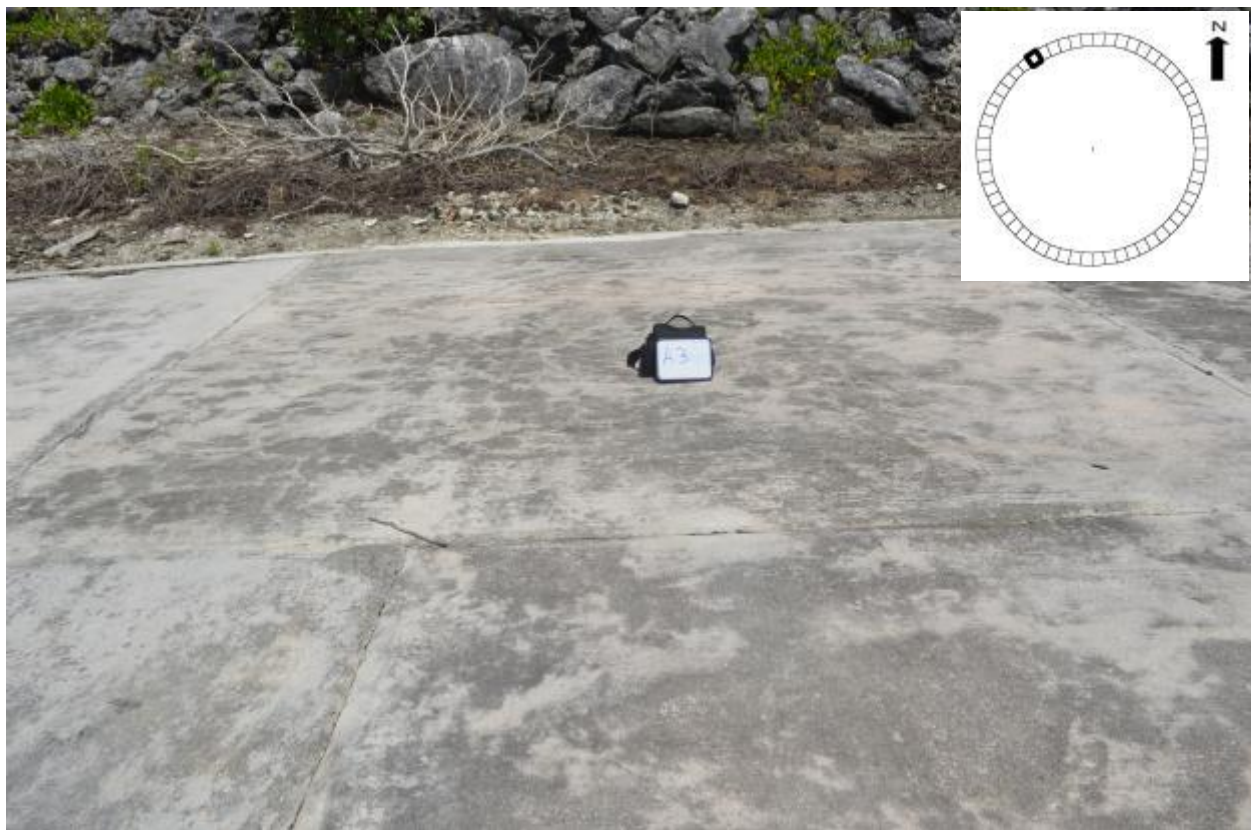
CAP SECTION LOCATION: Panel A3

No significant or obvious interior cracks extending across the top of the panel. The panel has a rough and weathered appearance. Some rooting vegetation removed from along the seams. Some minor spalling/chipping of concrete in the upper left-hand corner of the panel.

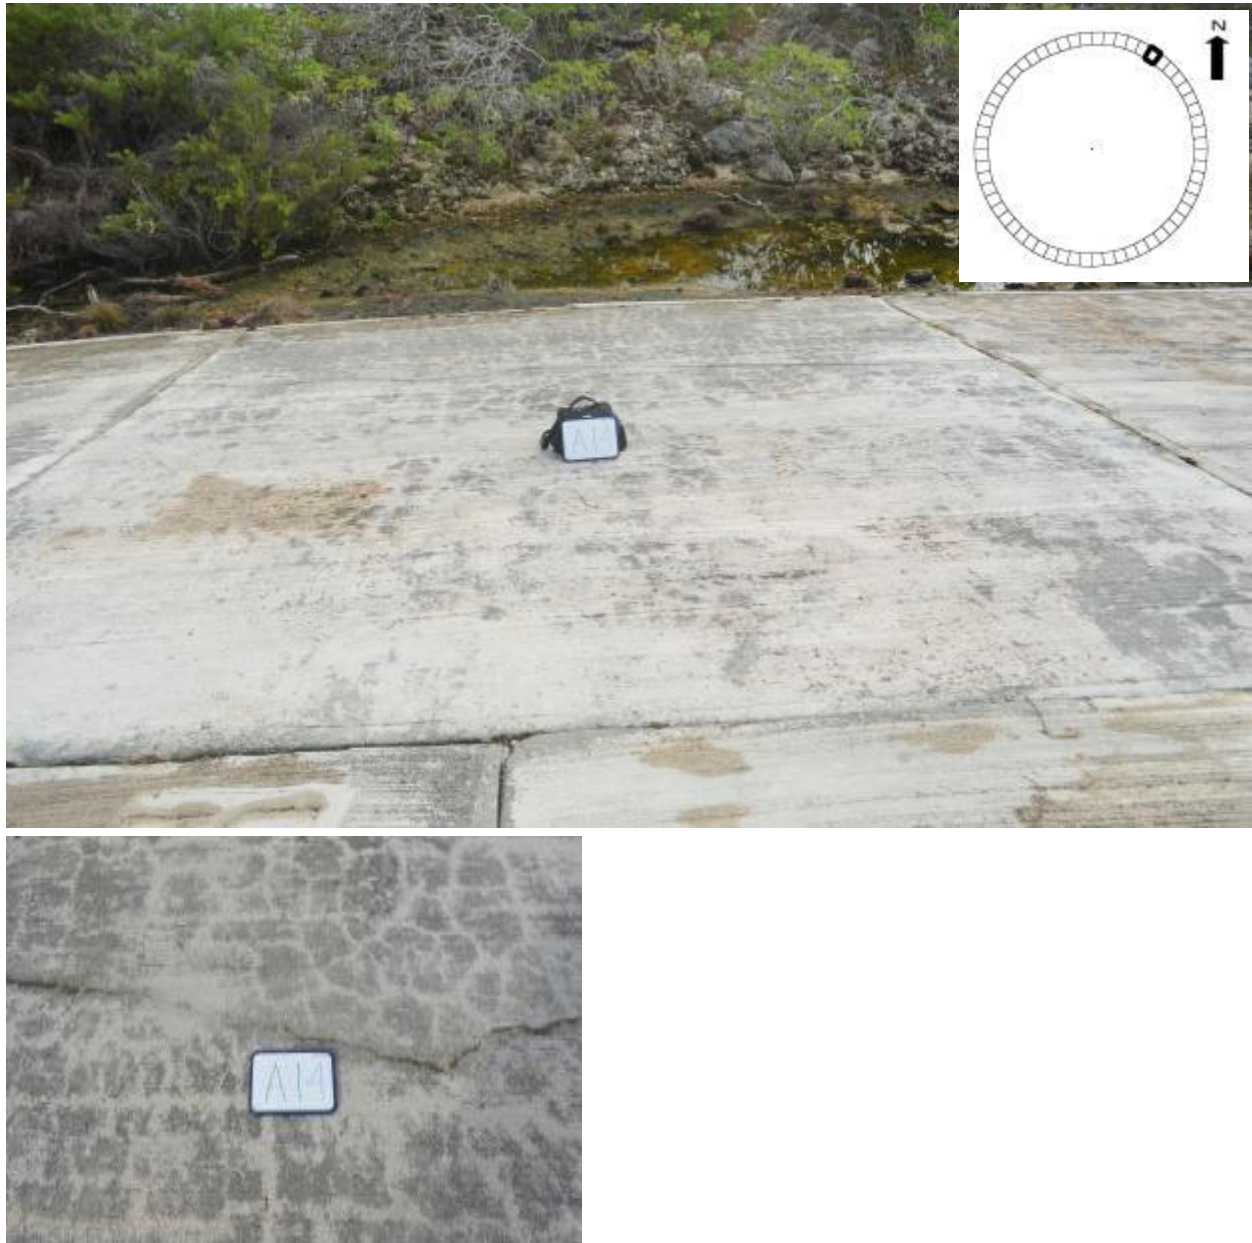
The panel has a relatively rough weathered appearance. Some rooting vegetation removed from along the seams. A surface crack observed traversing across the panel from a mid-point on the left and intersecting with the right-hand seam about 3 meters up from the bottom of the panel.

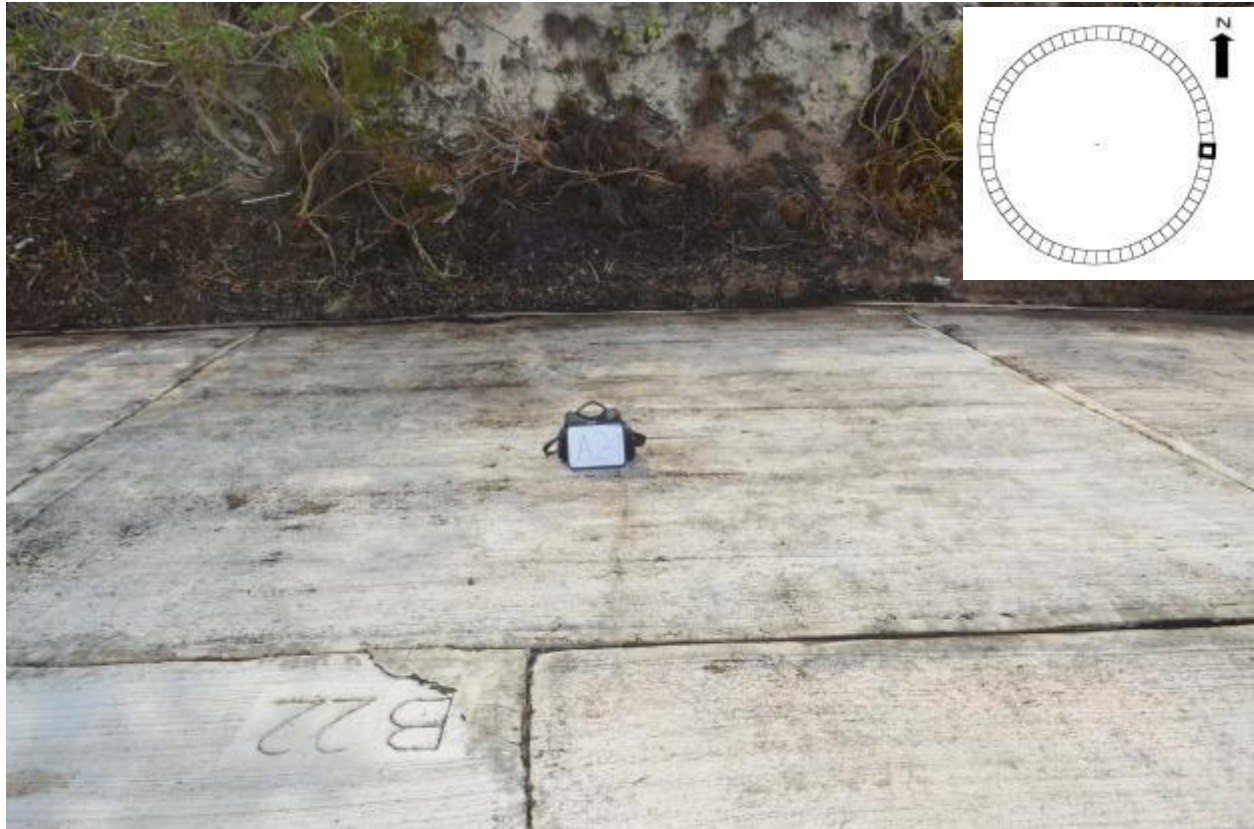
The panel has a rough and weathered appearance. A significant spall of concrete is visible along the seam adjacent to the keywall (several centimeters deep, and about 80 x 30 centimeters in area).

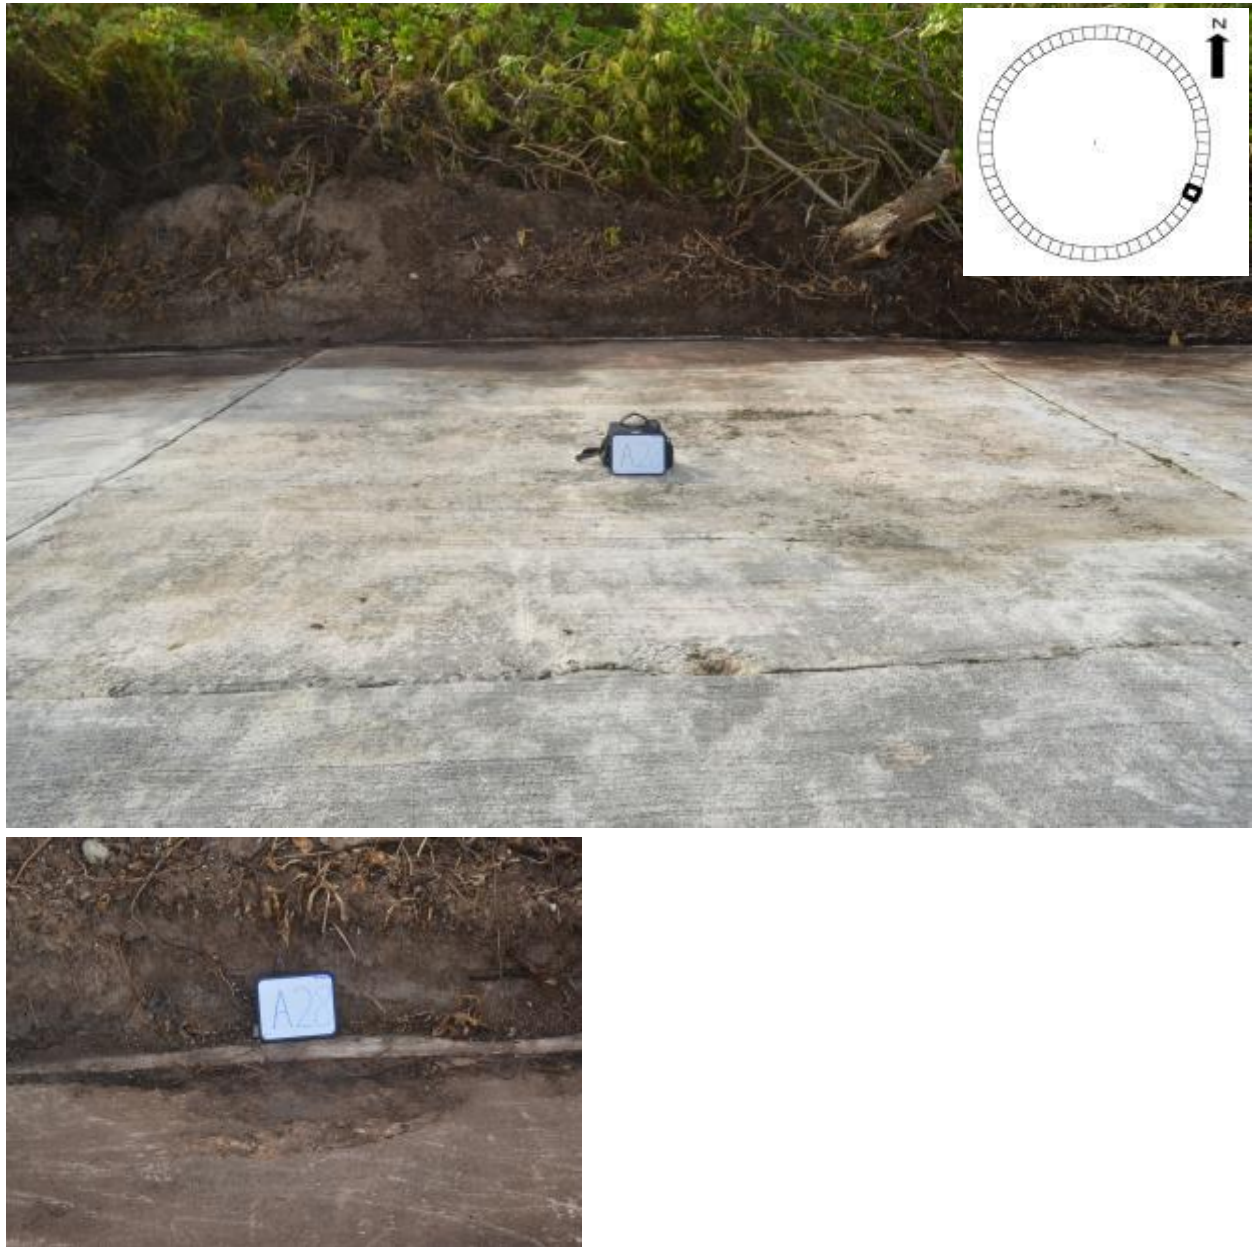
The panel has a rough appearance. Rooting vegetation removed from along the seams. Significant spalled sections of concrete observed along the bottom right-hand corner (app. 2 meters wide) and in a central location along the top seam of the panel. A scrub tree found growing over the keywall was cut down and the stump removed. Some minor spalling of concrete observed in the top right-hand corner of the panel.

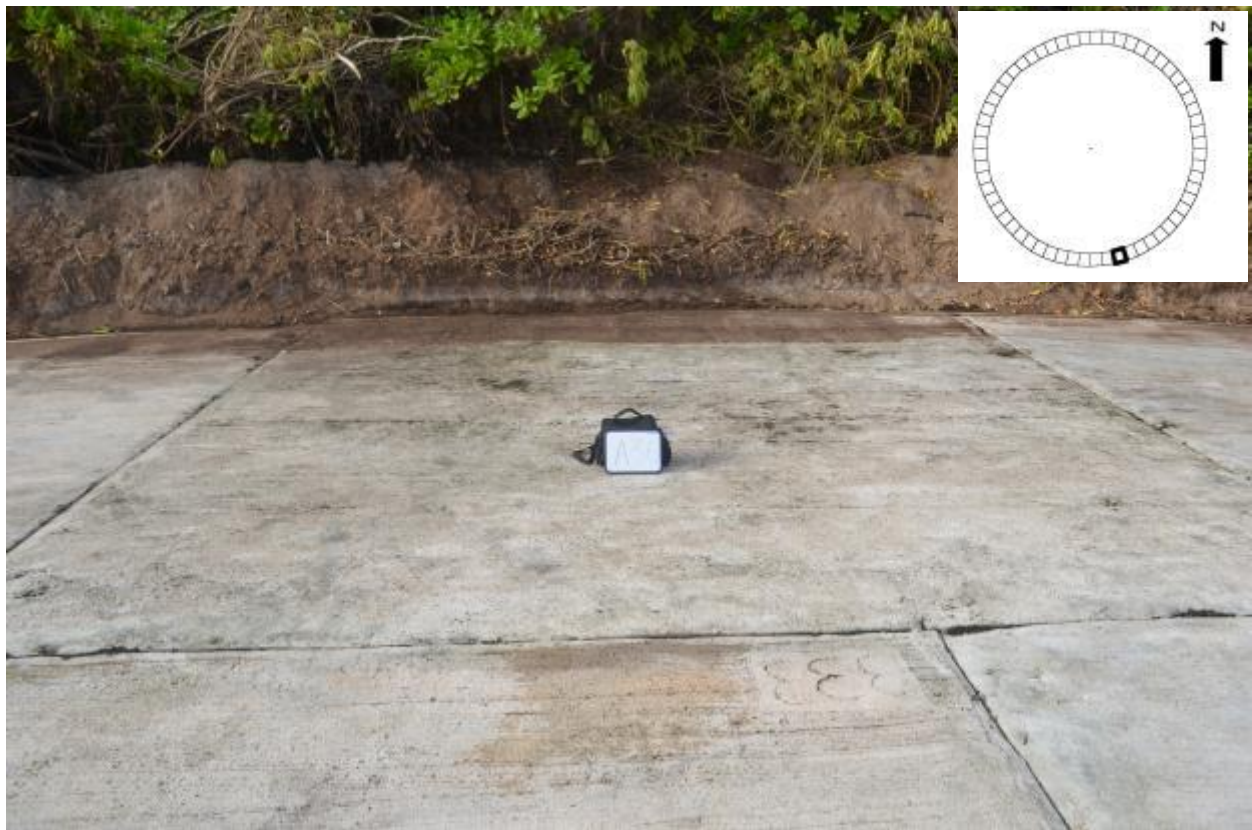
The panel has a relatively rough and weathered appearance. Rooting vegetation removed from along the panel seams. Some minor spalling of concrete observed in the top left-hand corner, and along the top left seam, of the panel.

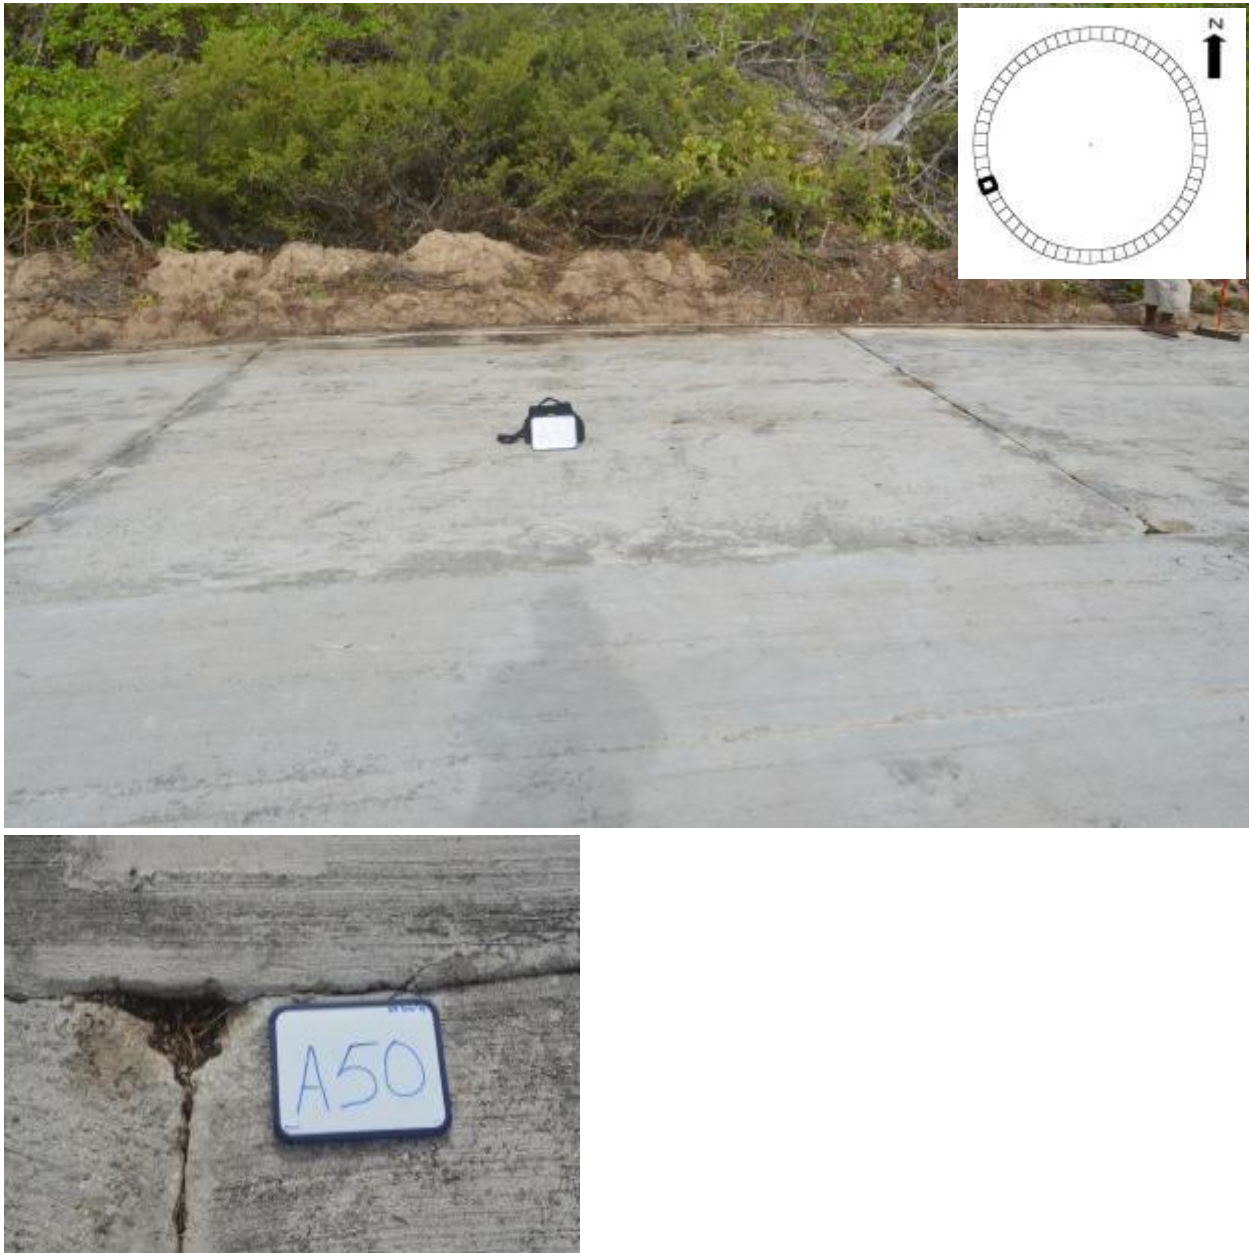
No significant or obvious interior cracks extending across the top of the panel. Rooting vegetation removed from along the panel seams. Some spalling/chipping of concrete observed in the upper left and right-hand corners of the panel.

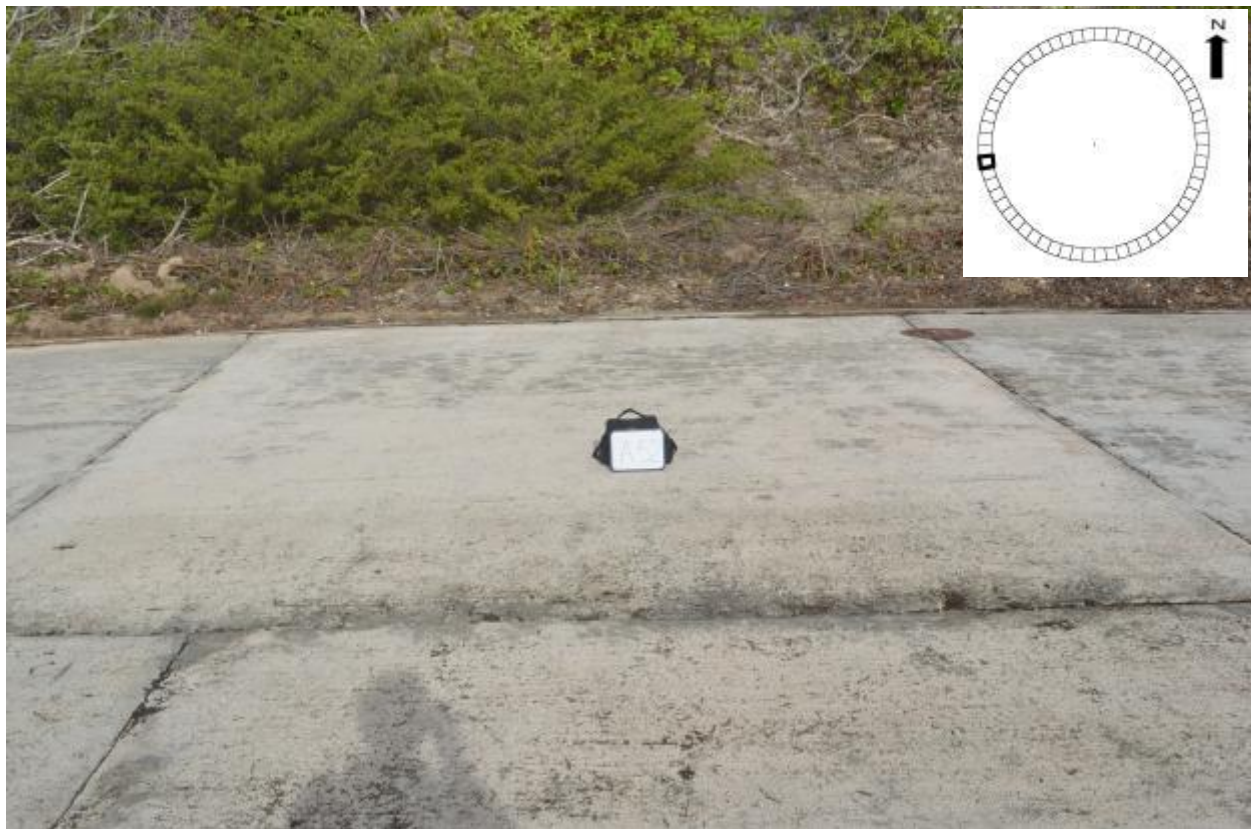
No significant or obvious interior cracks extending across the top of the panel. The panel has a relatively rough appearance. Rooting vegetation removed from along the panel seams. Some minor spalling with small chipped out pieces of concrete observed along the left side of the top seam.

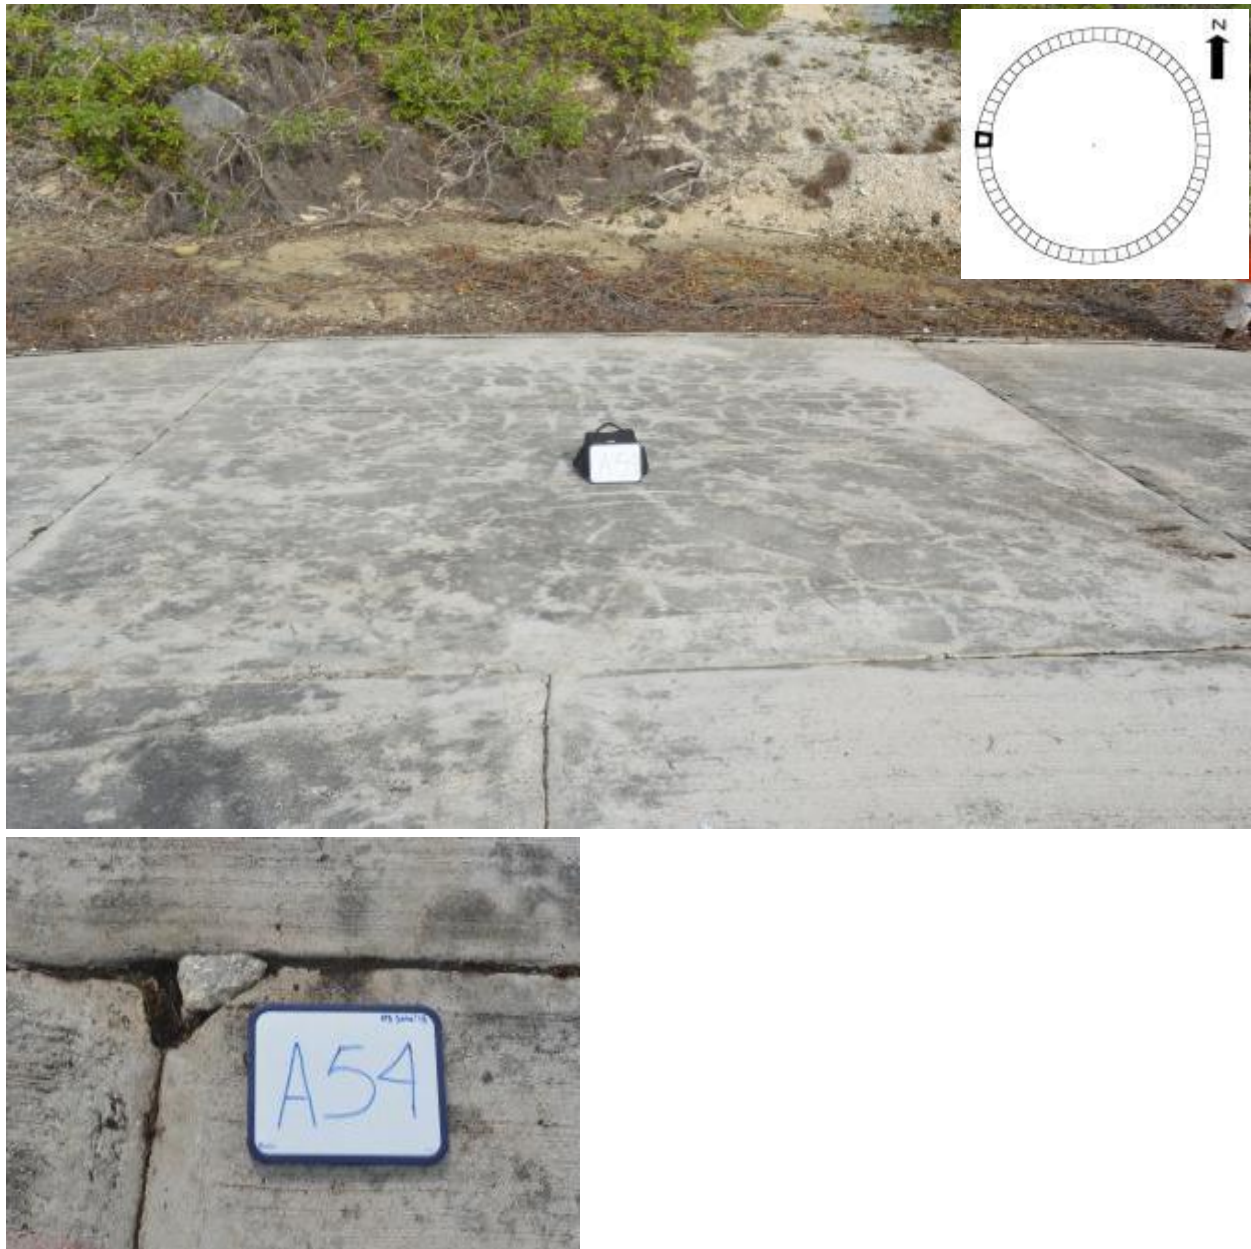
No significant or obvious interior cracks extending across the top of the panel. Panel has a relatively rough appearance. Rooting vegetation removed from along the panel seams. Rooting vines appear to have caused some spalling/cracking of concrete in the upper left-hand corner. Panel contains a capped concrete bore-hole (CD-18) from the 1980 NAS investigation.

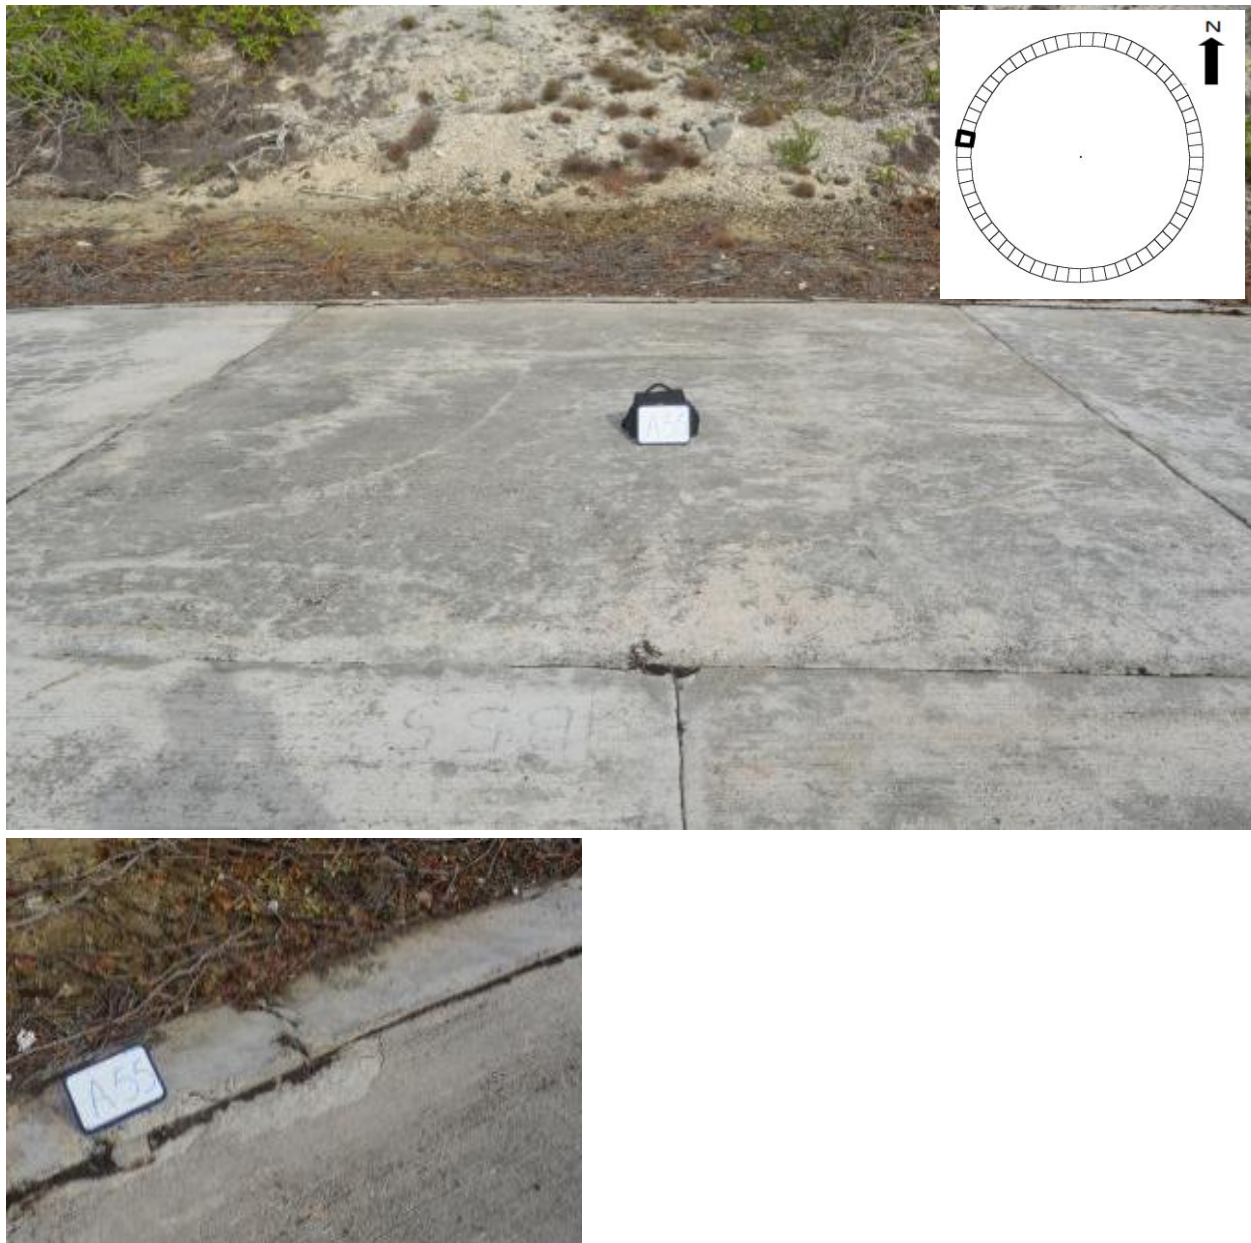
CAP SECTION LOCATION: Panel A55

No significant or obvious interior cracks extending across the top of the panel. Panel has a relatively rough appearance. Rooting vegetation removed from along the panel seams. Rooting vines appear to have caused some spalling/cracking of concrete in the upper right corner. Significant spalling of concrete appearing along the right bottom seam (chipped section is about 1.2 meters in length) adjacent to the keywall.

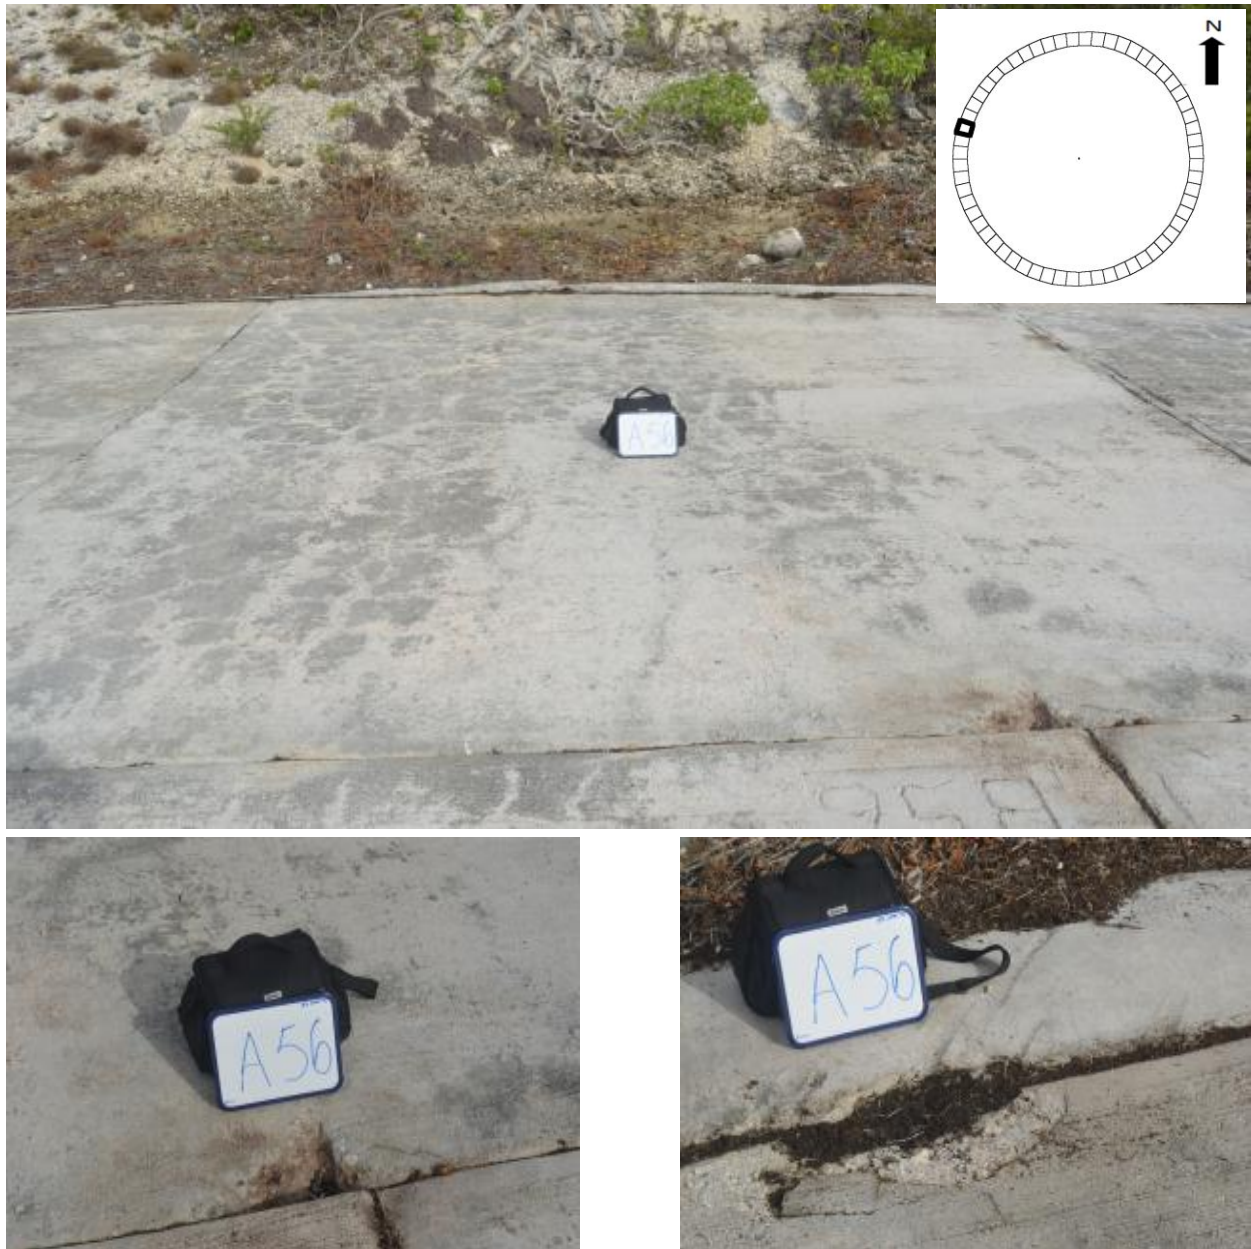
CAP SECTION LOCATION: Panel A56

Rooting vegetation removed from along the panel seams. Some minor spalling of concrete observed along the top seam with the chipped out section extending down about half the depth of the panel cap. More significant spalling/chipping of concrete along the bottom seam adjacent to the keywall about 2 meters distance from the left edge of the panel.

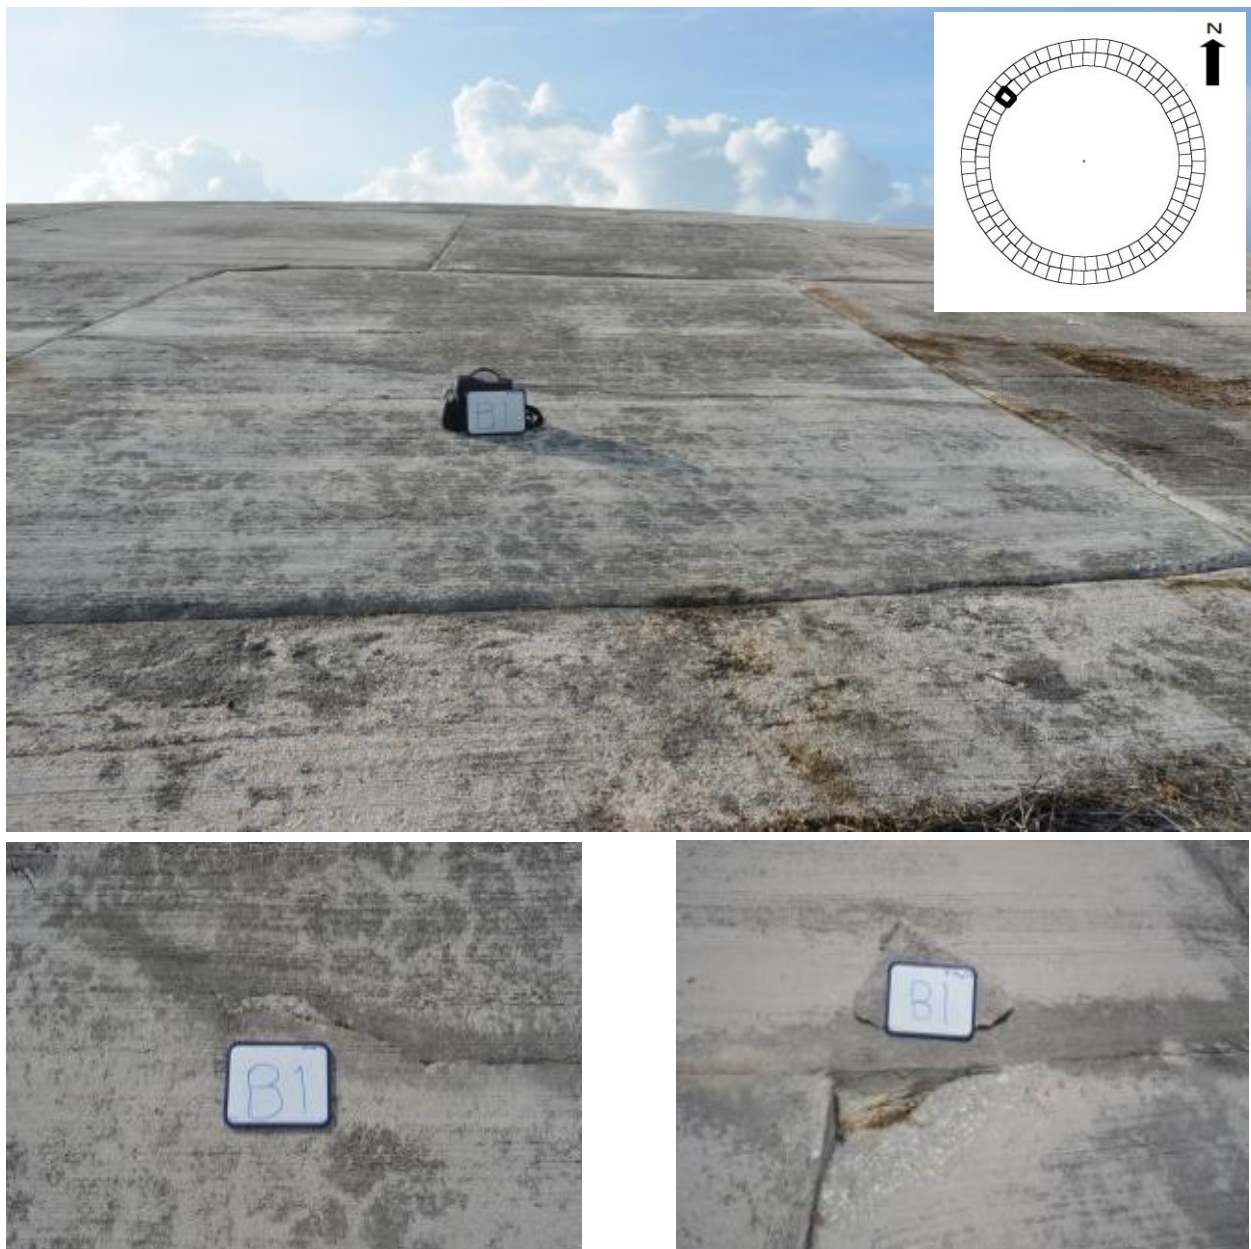
Significant spalling of concrete observed in upper right corner where the chipped out piece of concrete extends down to contaminated soil – cement grout waste pile mixture below. Surface crack observed running across the full width of the panel at a mid-point up the segment. Rooting vegetation removed from along the panel seams. Panel recommended for priority repair.

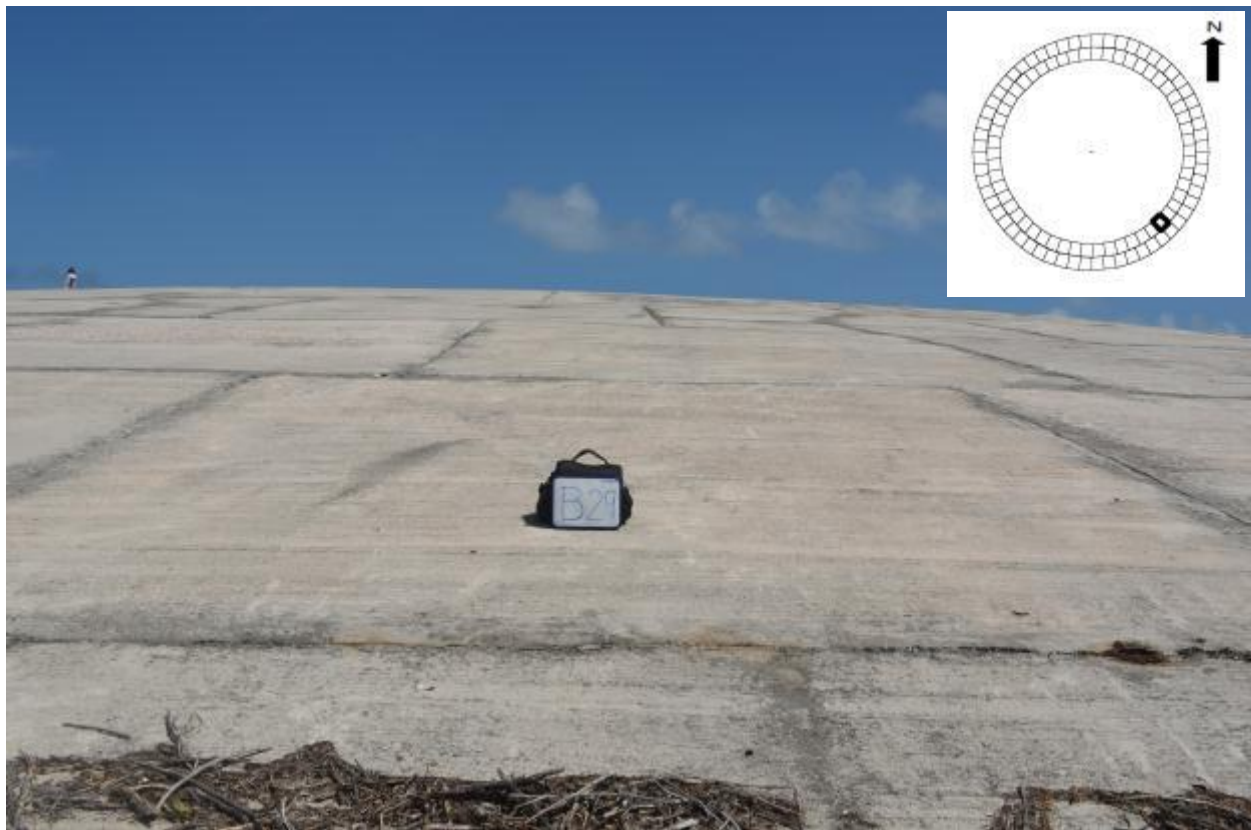
No significant or obvious interior cracks extending across the top of the panel. The panel appears to have a relatively rough appearance. Rooting vegetation removed from along the panel seams. Some minor spalling of concrete observed along the bottom left seam overhanging the A panel below.
